NASA CR-129041

CHARACTERIZATION OF METALS MELTING DISCS
SKYLAB EXPERIMENT M551

By Robert E. Monroe
Battelle Columbus Laboratories
Columbus, Ohio 43201

January 1974

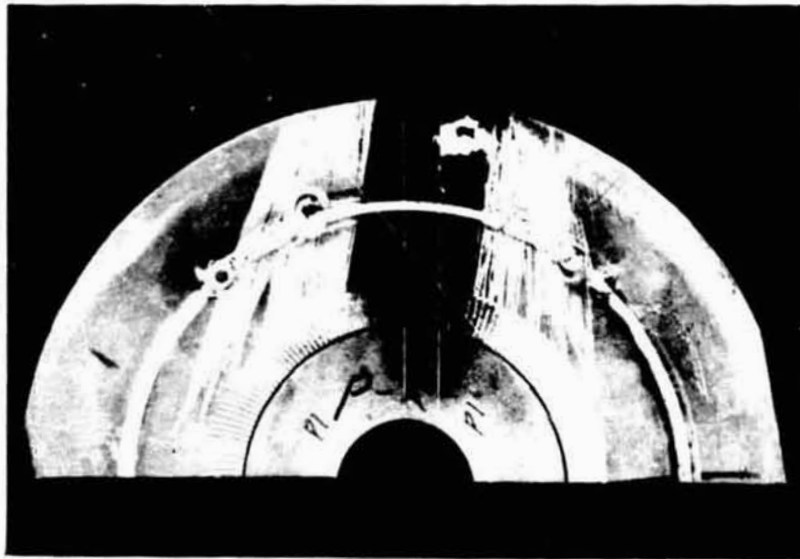
No defects were noted in the radiograph except for cracks at the weld stops and dwells. Figure A-2 shows the appearance of this disc as received. The black area is a molybdenum spray coating used for a tracer. A section through the weld zone in the area of the tracer is shown in Figure A-3. No adverse effects of the tracer on the weld region were noted in this section.

FIGURE A-2. FRONT SURFACE OF P-1 2G905-0.5X

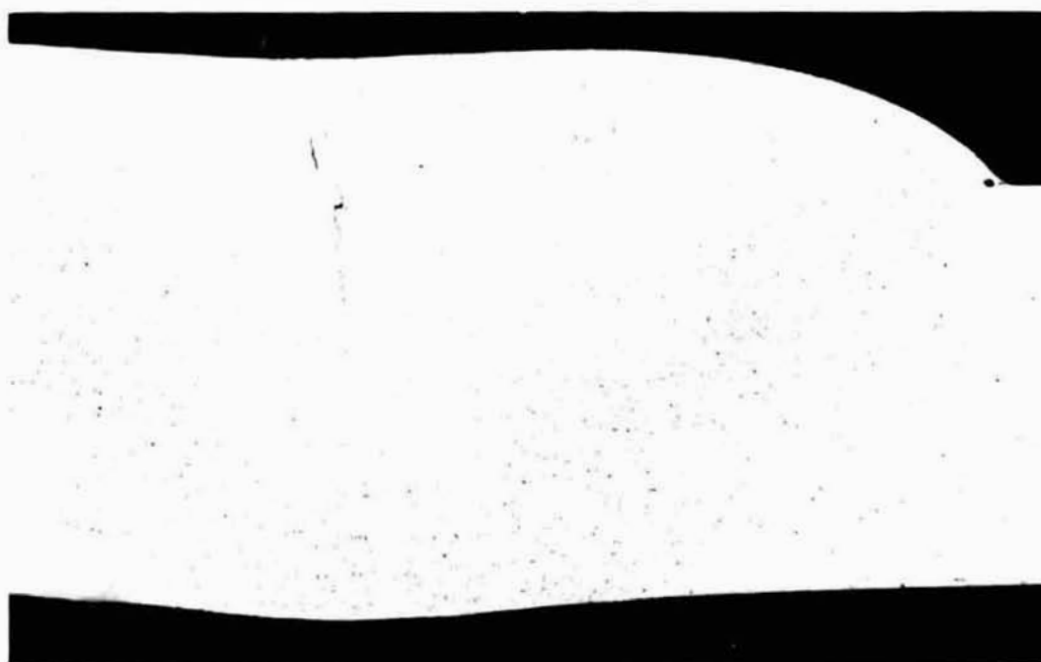
FIGURE A-11. SECTION THROUGH CRACK NEAR WELD START

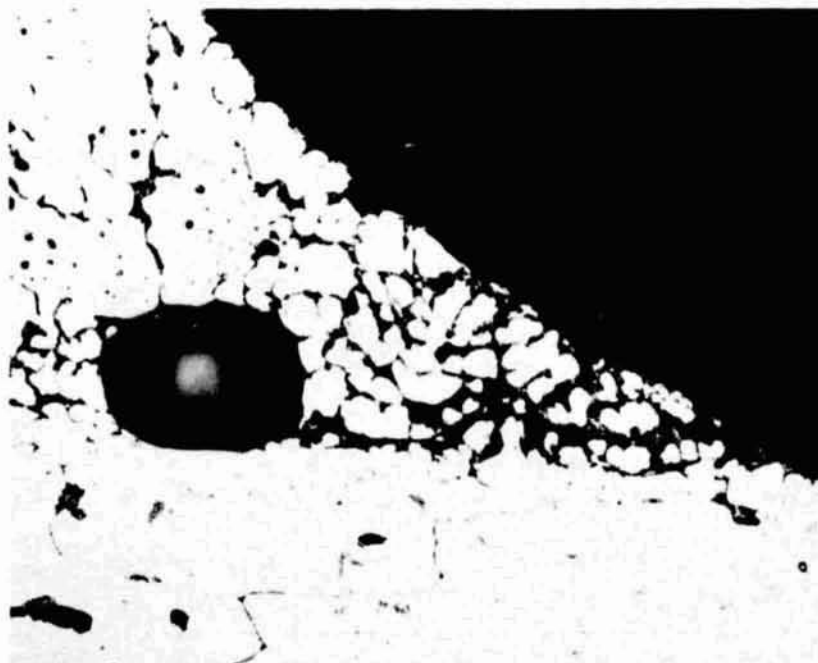
FIGURE A-13. PORE AT INSIDE EDGE OF WELD - H-1

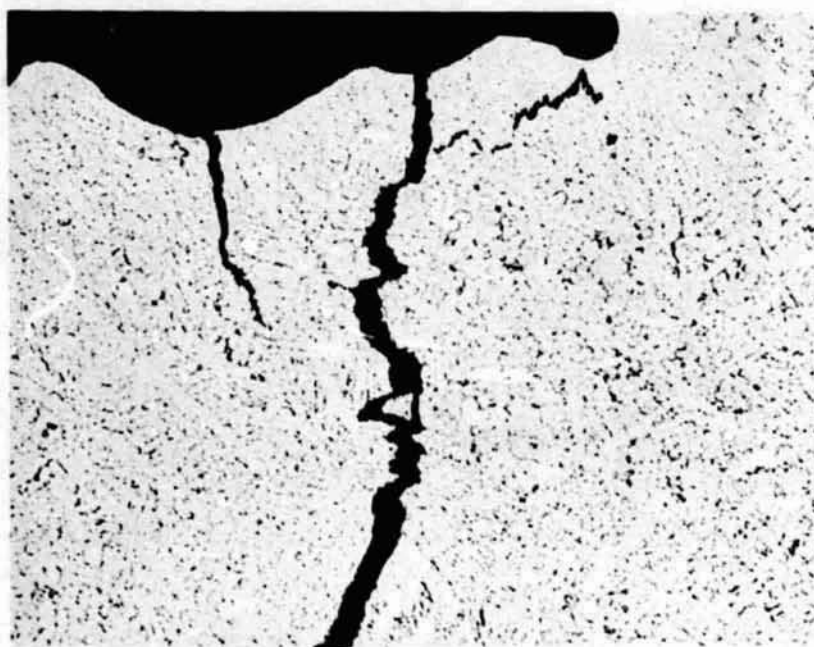
b. Main crack near center in Figure A-19

FIGURE A-20. CRACKS IN DWELL REGION- H-1

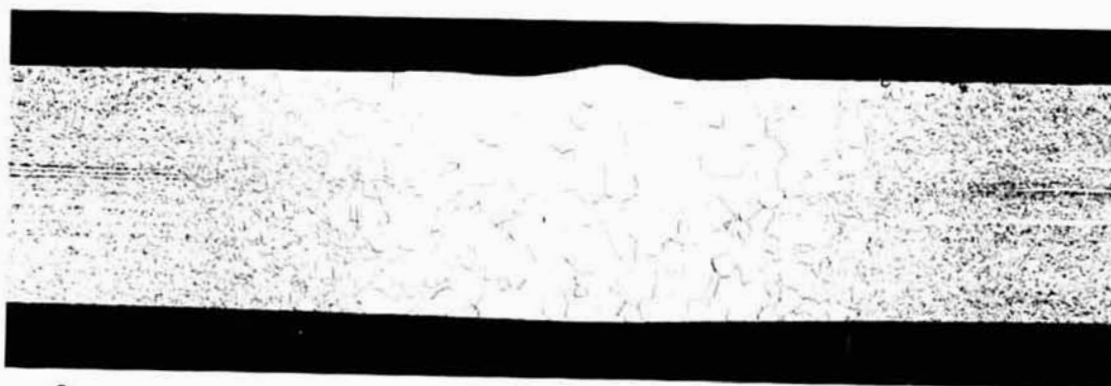
FIGURE A-63. CHORD SECTION
THROUGH DWELL
REGION S/N 143

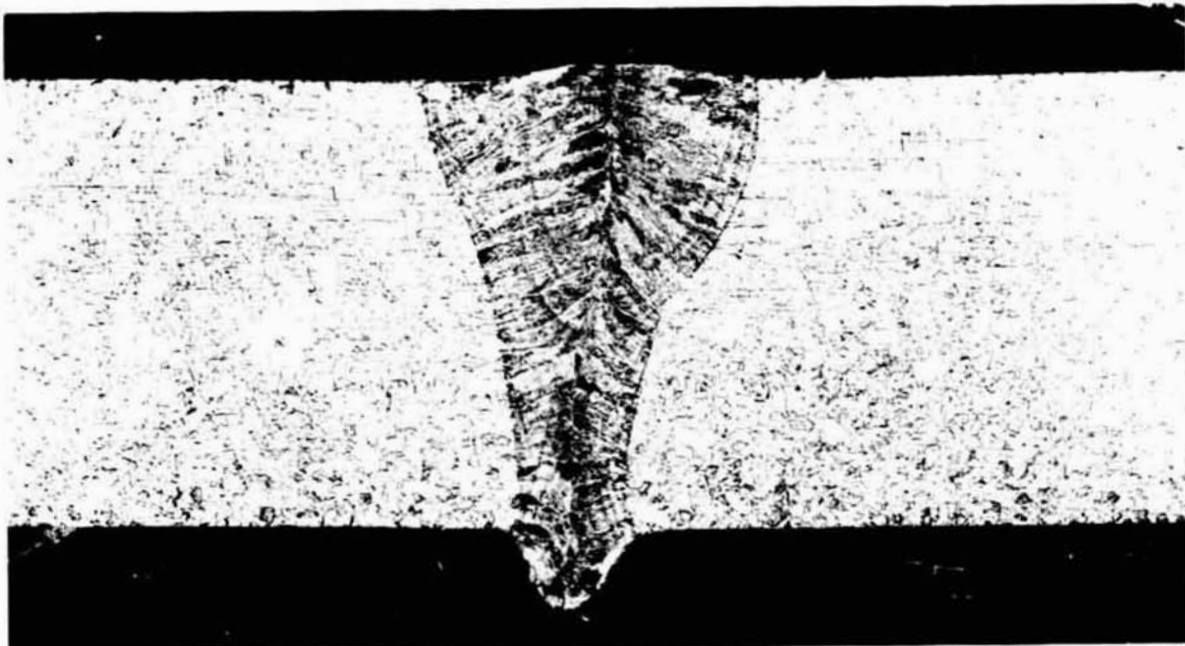
(a) The stainless steel welds exhibited the nail-head penetration shape commonly found in this material. However, the shape was asymmetrical in both welds (Figure B-24). Penetration was deeper on the ground sample than on the Skylab sample, but this probably reflects a slight difference in power density. The dwell regions (Figures B-17 and B-19) also indicated an effect of nonuniform power input. Normally, a circular melt zone would result from the spot heating in the dwell region. However, both discs exhibited an oblong melt zone about 18 x 10 mm in size. The melt shape indicates that the effective electron beam focal pattern was elongated.

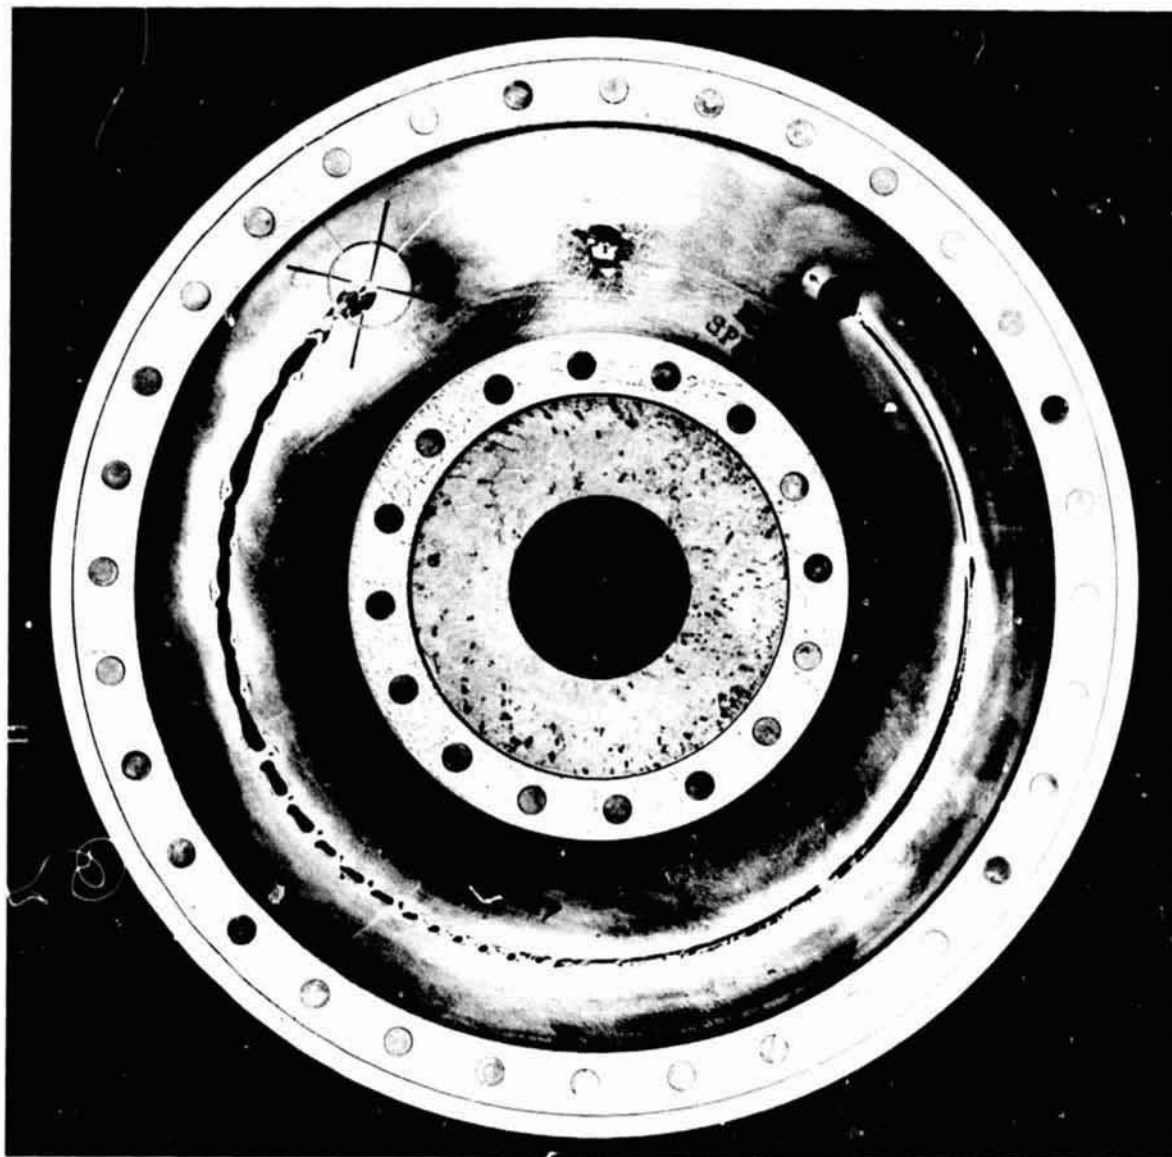
FIGURE B-32. FRONT SURFACE S/N 147
